NATIONAL PROGRAM FOR INSPECTION OF NON-FEDERAL DAMS
BUCKLEY-DUNTON DAM (M. U) CORPS OF ENGINEERS WALTHAM
MA NEW ENGLAND DIV AUG 81

BUCKLEY-DUNTON DAM
MA 00202

PHASE I INSPECTION REPORT
NATIONAL DAM INSPECTION PROGRAM

AUGUST 1981

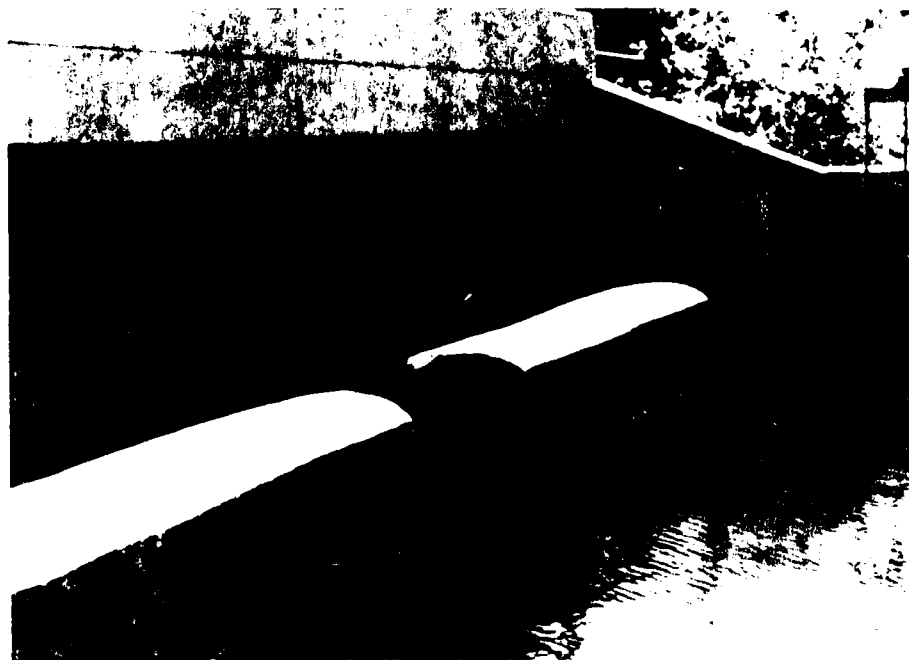
PHOTO NO. 15 - View of spillway weir.

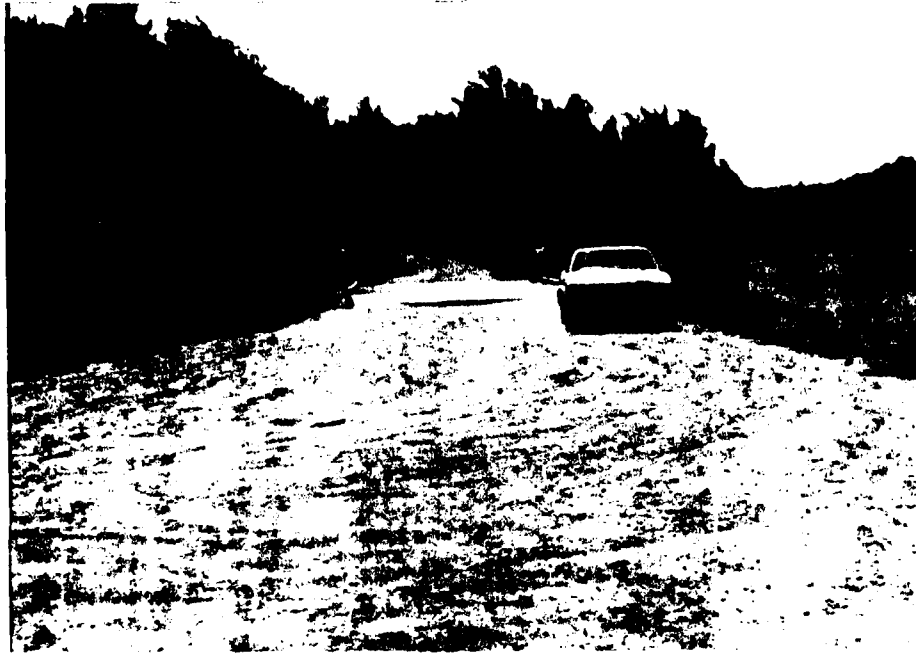
The dam crest is paved with asphalt between the right abutment and the concrete spillway bridge (photograph 1) and is unpaved between the bridge and the left abutment (photograph 12). No misalignment or cracking of the crest was observed.

PHOTO NO. 12 - Dam crest from left abutment, showing minor erosion of crest on left side of concrete bridge deck.

4. The minor erosion on the left side of the concrete road surface should be repaired.
5. The concrete erosion at the concrete-stone interface of the left training wall should be repaired.

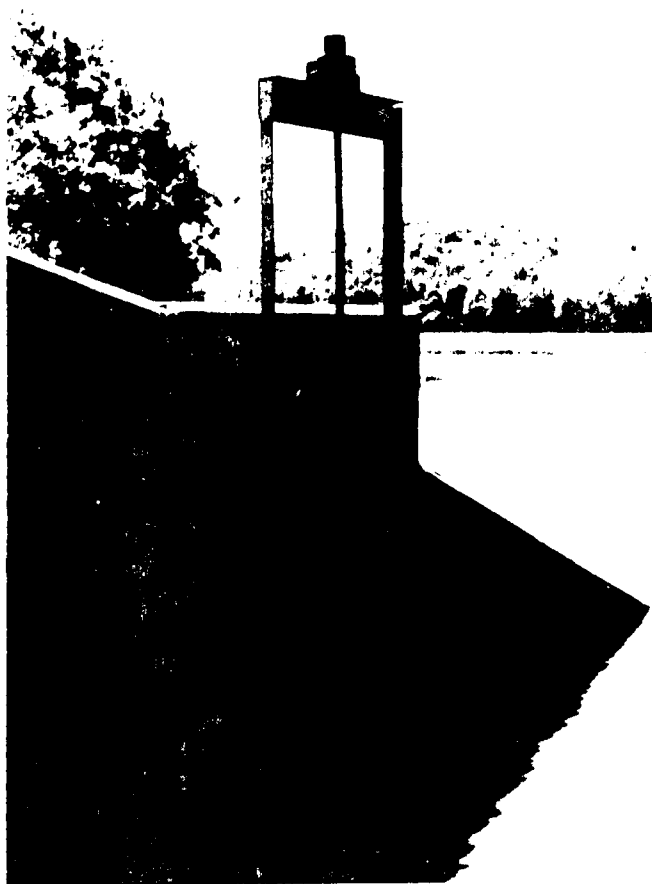
PHOTO NO. 6 - View of manually controlled gate for main drain.

6. The sluice gate should be operated yearly and repaired if necessary to insure continued adequacy.
7. All animal borrows should be backfilled.
8. The Owner should locate and make readily available, the design and construction data for the dam.

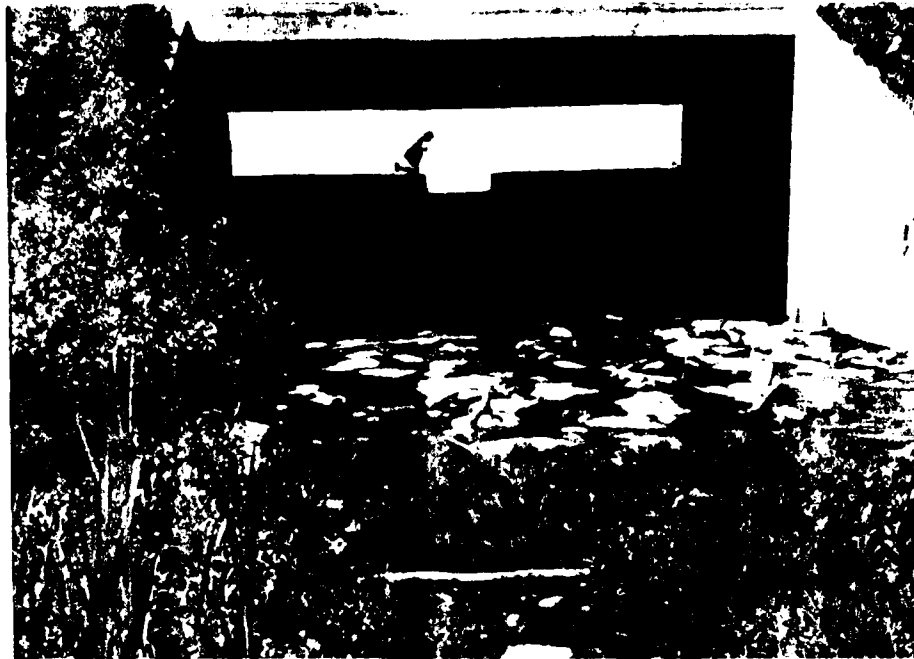
The spillway apron, shown in photograph 4, is lined with concrete and riprap. Several small springs were observed spurting

PHOTO NO. 4 - Spillway apron from discharge channel.

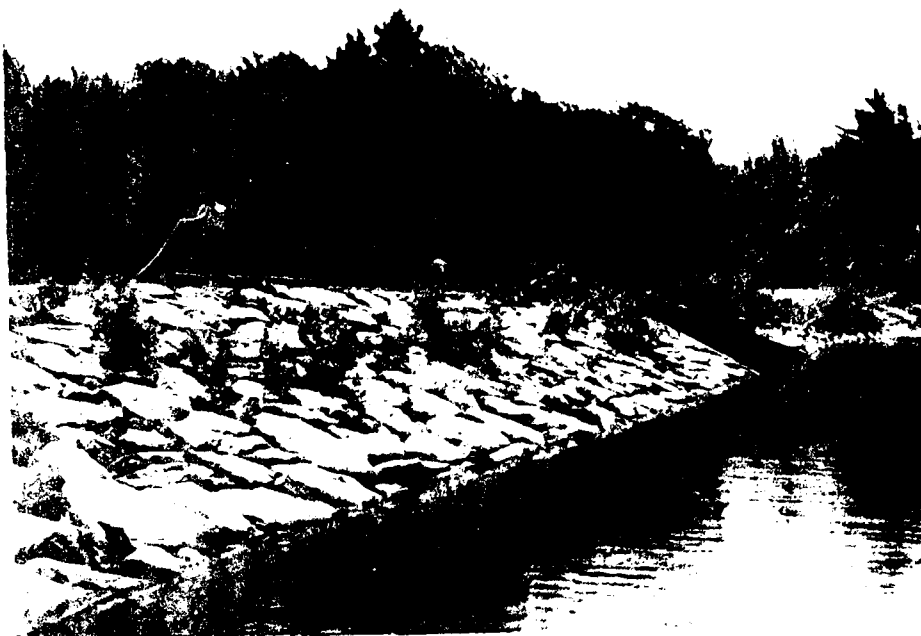
The upstream face of the dam shown on Photograph 2, has a slope of about 2H:1V. Above the waterline, the slope is covered up to the dam crest with hand-placed riprap, in good condition. Some brush up to 4 feet tall is growing on the slope.

PHOTO NO. 2 - Upstream face from left abutment showing riprap and small brush.
